TECHNICAL REPORT HL-90-18

RIO PUERTO NUEVO FLOOD-CONTROL PROJECT SAN JUAN, PUERTO RICO

Hydraulic Model Investigation

Prepared for US Army Engineer District, Jacksonville
Jacksonville, Florida 32232-0019

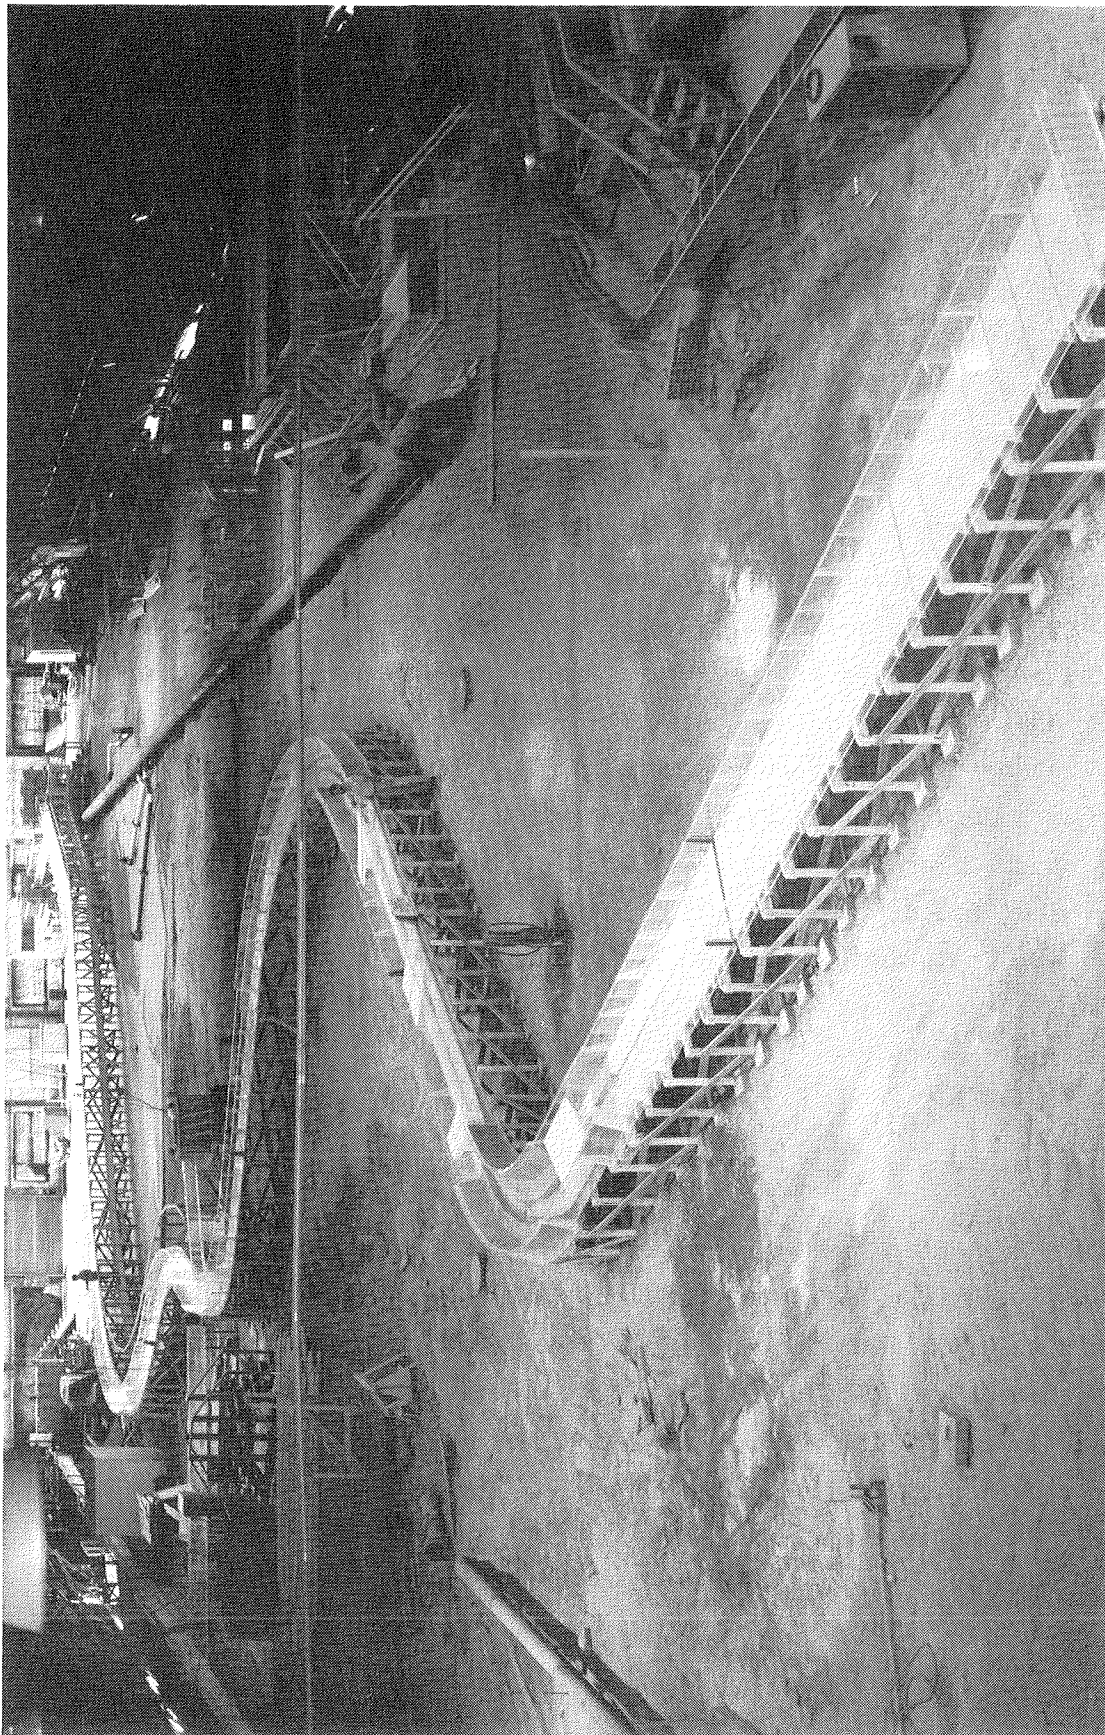
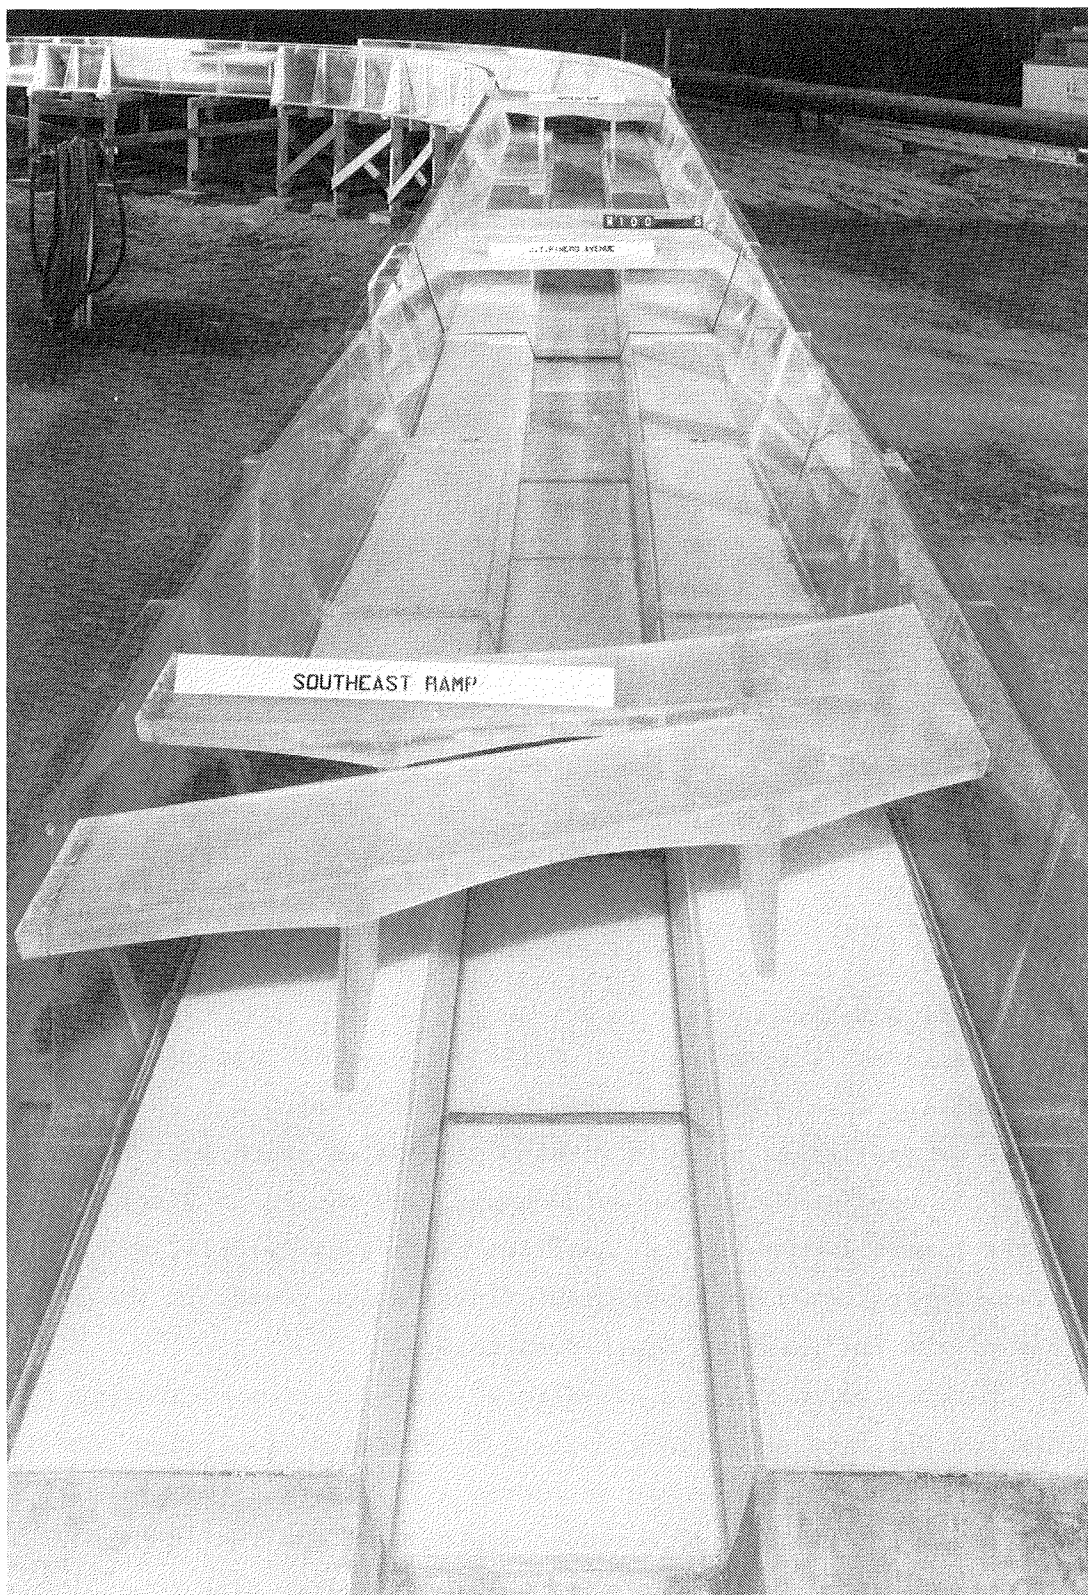
Figure 2. The Puerto Nuevo model (Continued)

a. General view

b. Between curves 9 and 10 (looking downstream)

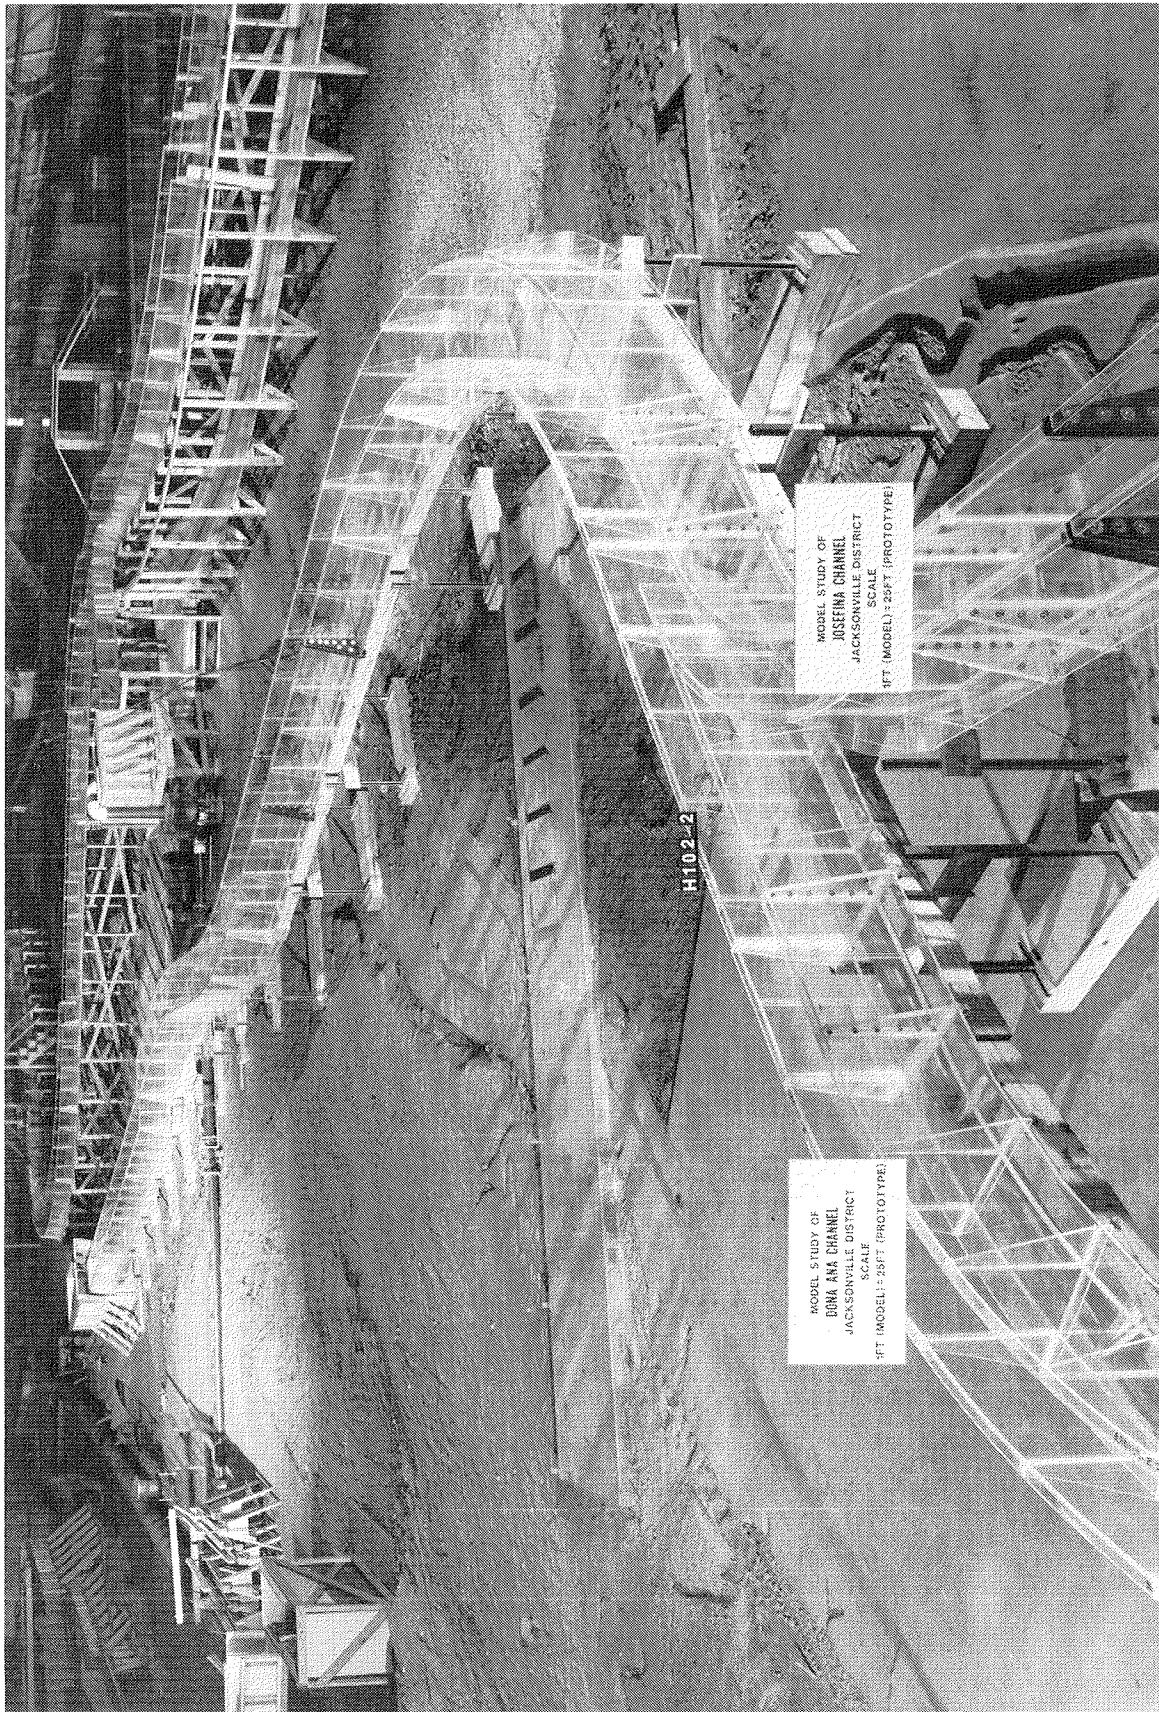
Figure 3. General view of model looking downstream

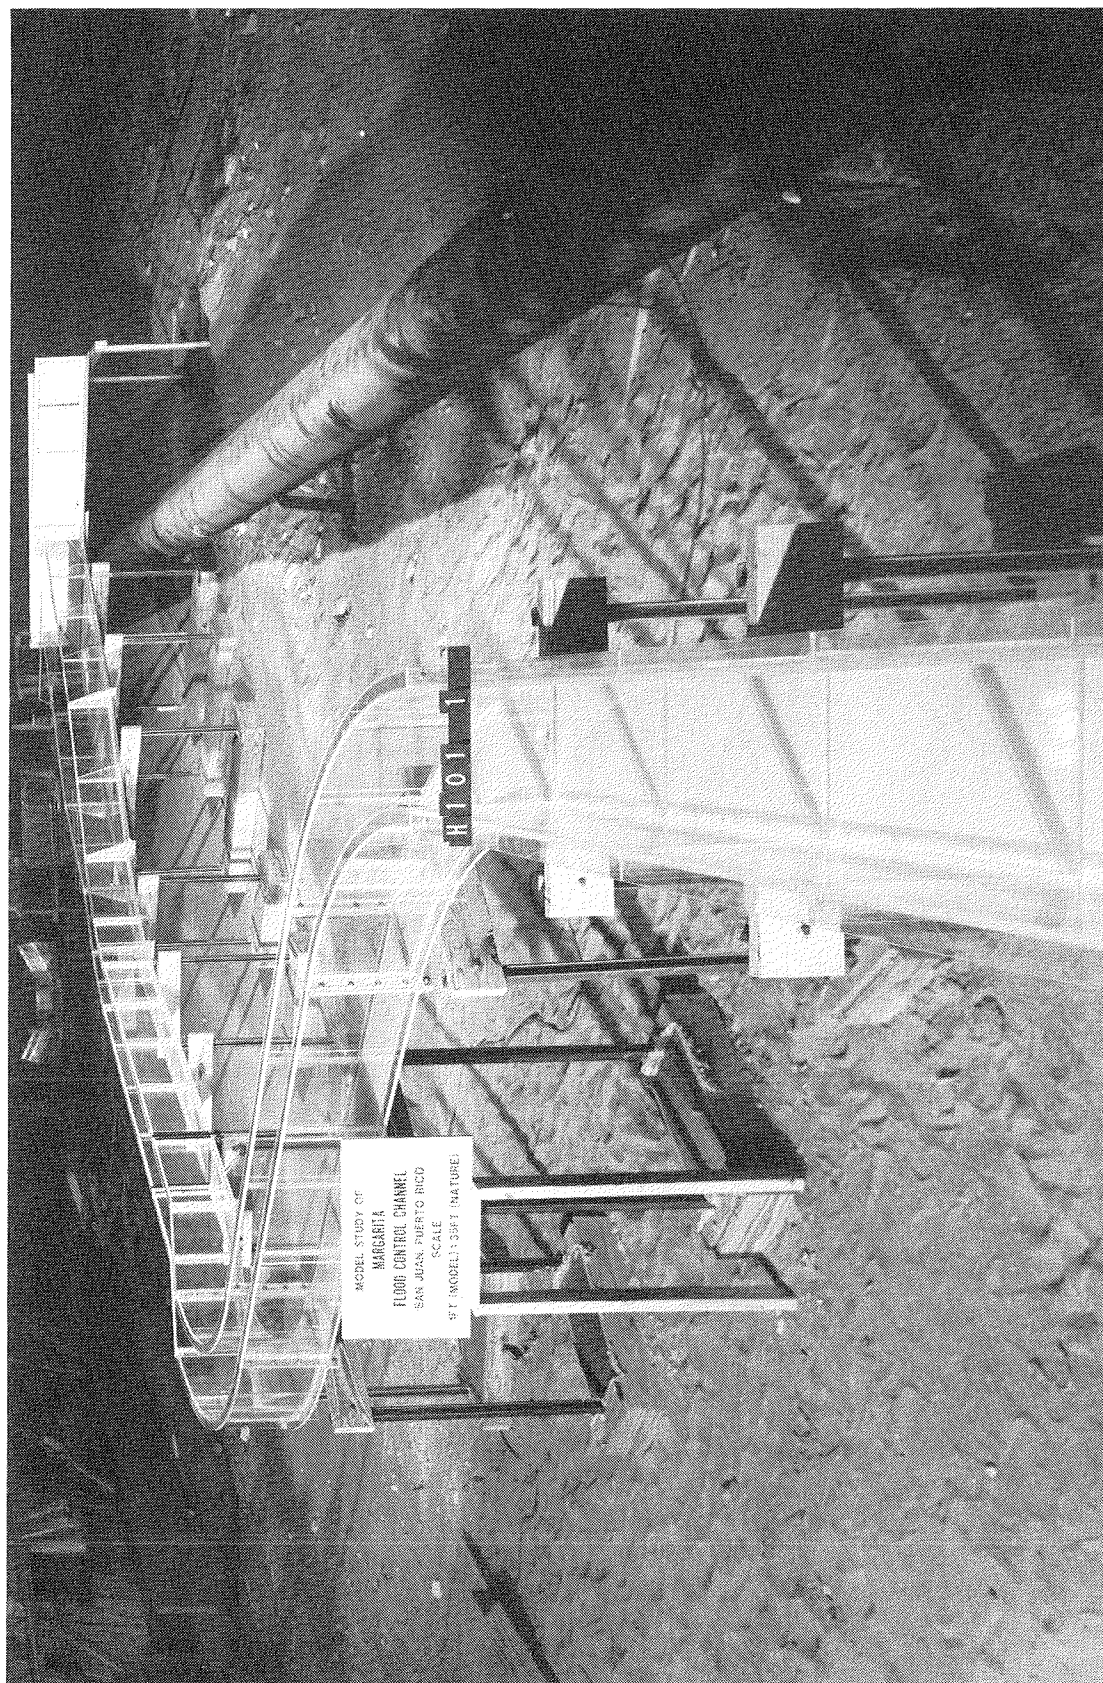
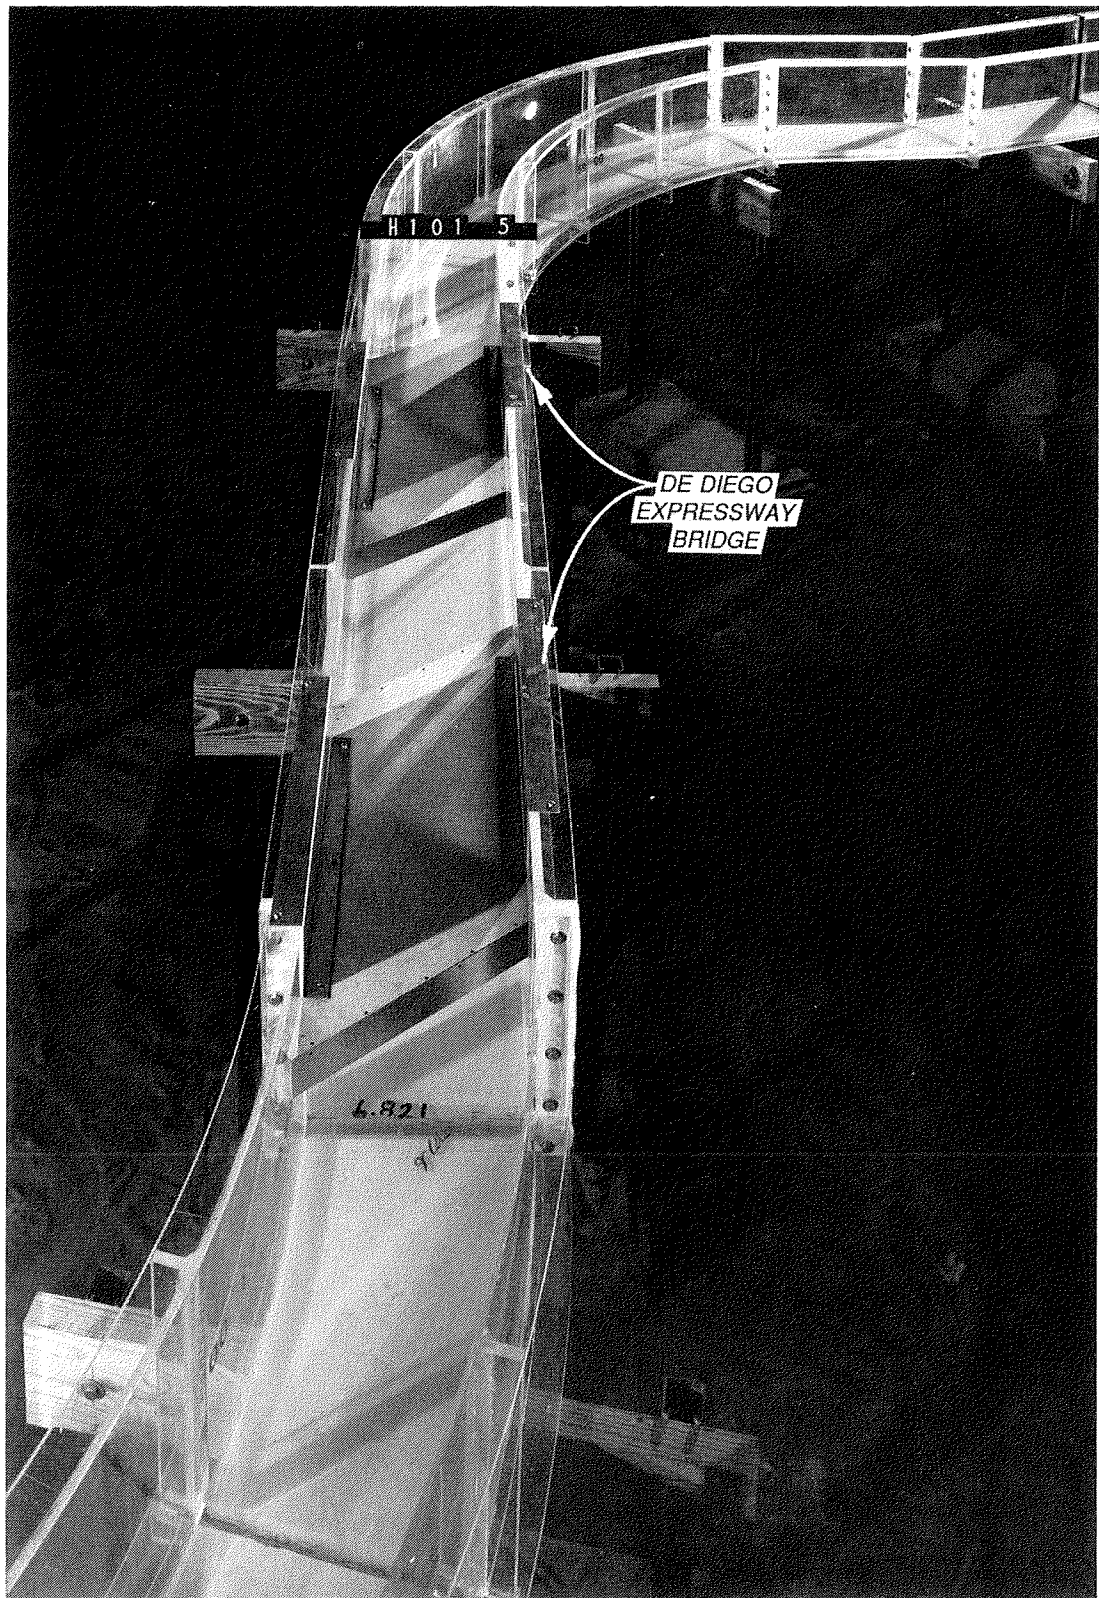
Figure 4. The Margarita model (Continued)

a. General view (looking downstream)

b. De Diego Expressway Bridge (looking downstream)

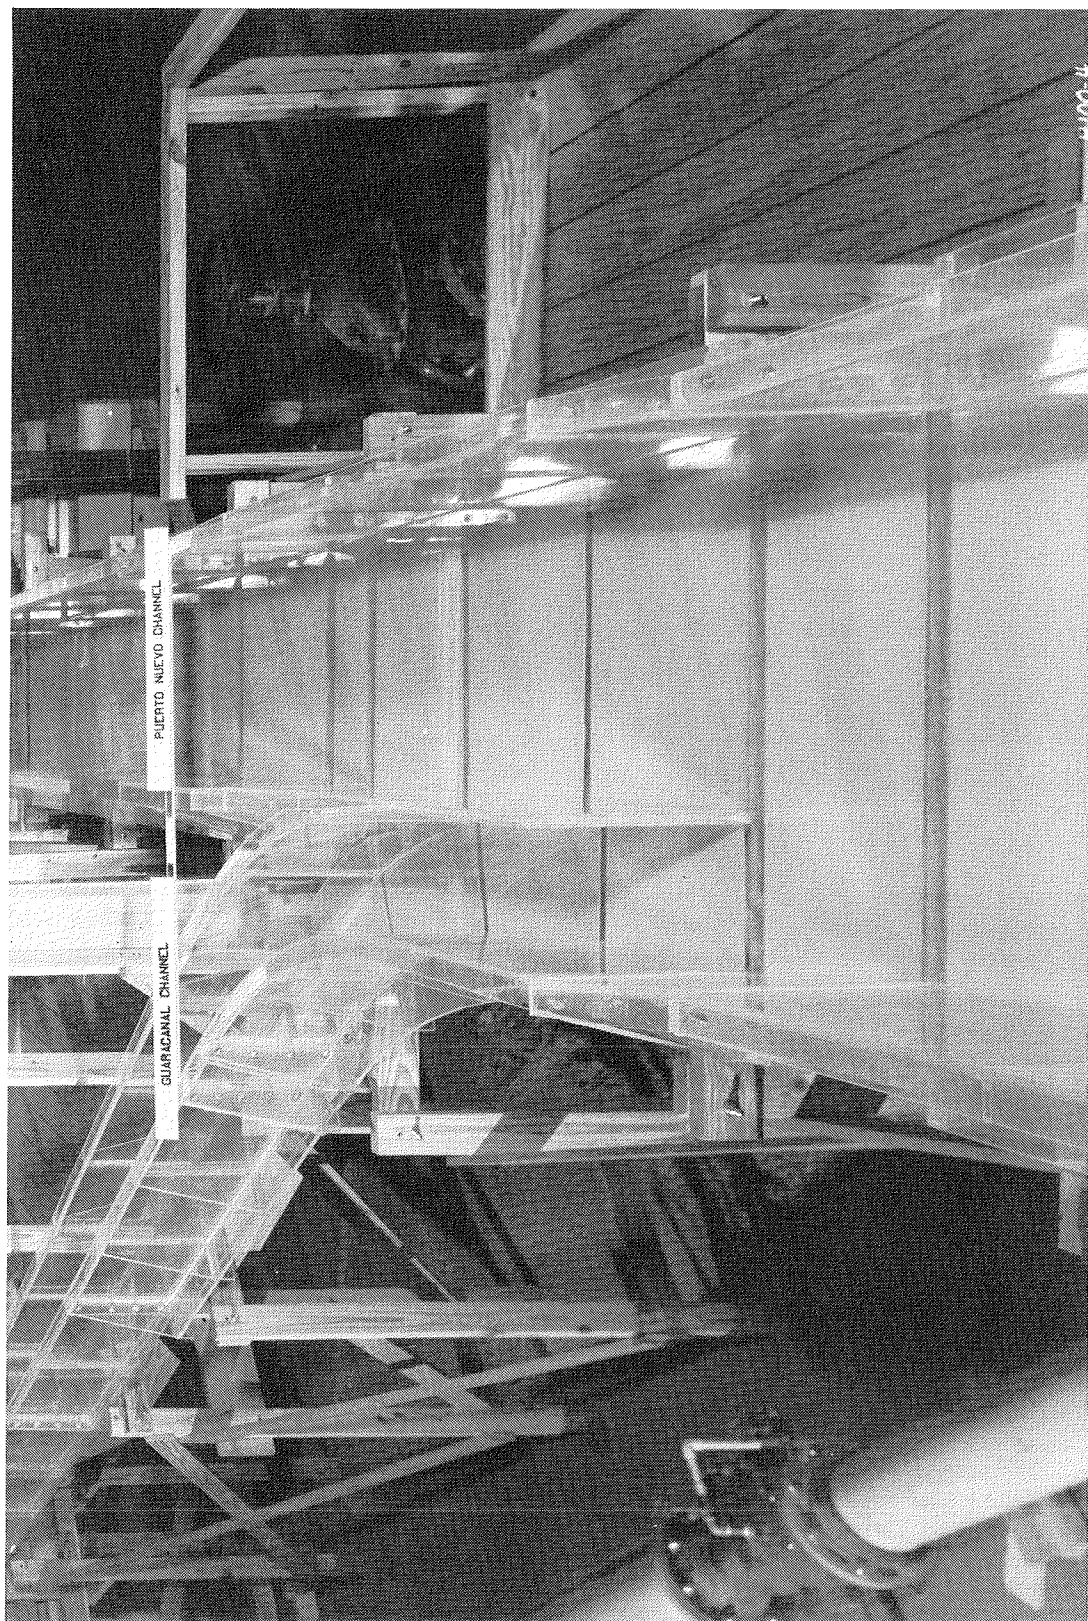
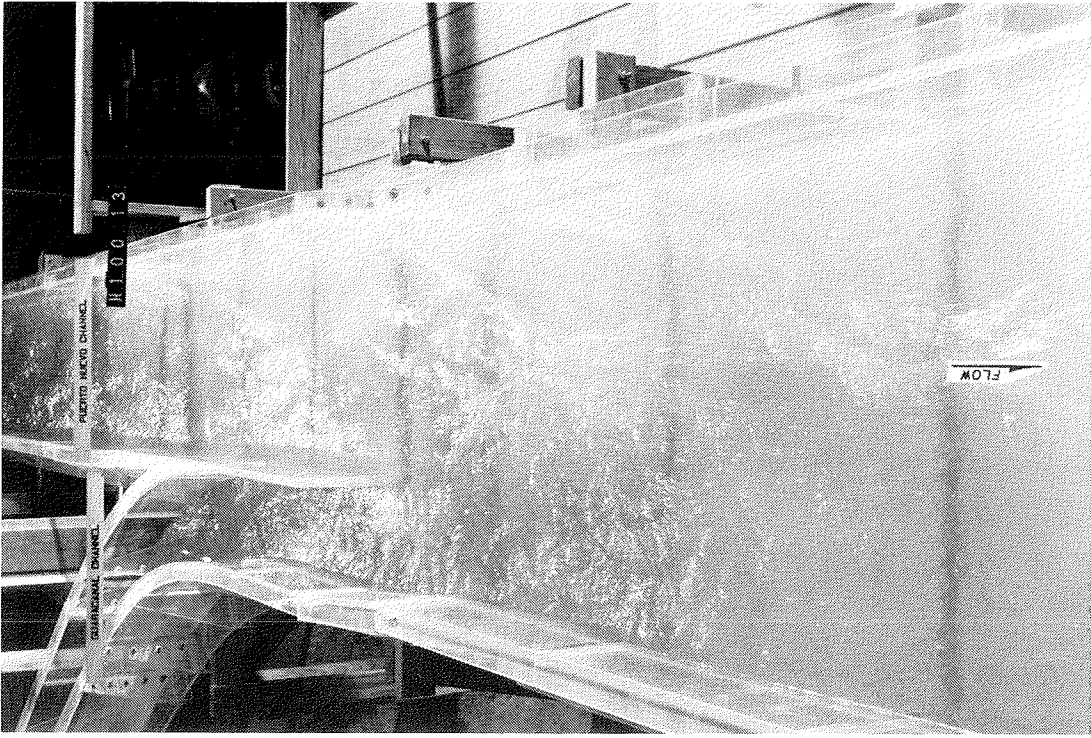
a. Dry bed (looking upstream)

Photo 1. Flow conditions, type 1 (original) design, Puerto Nuevo/Guaracanal confluence, discharge 26,100 cfs in Puerto Nuevo, 8,000 cfs in Guaracanal, $n = 0.015$ (Continued)

b. Looking upstream

c. Looking downstream

11. Maximum water-surface elevations* were measured for design flow conditions for the type 1 design (Tables 1-3, Plates 8-14). Flow conditions for the design discharge are shown in Photos 1-7. Initial test results indicated that no design changes were needed upstream of the Puerto Nuevo/Buena Vista Diversion Channel confluence (Plate 15). However, flow conditions in

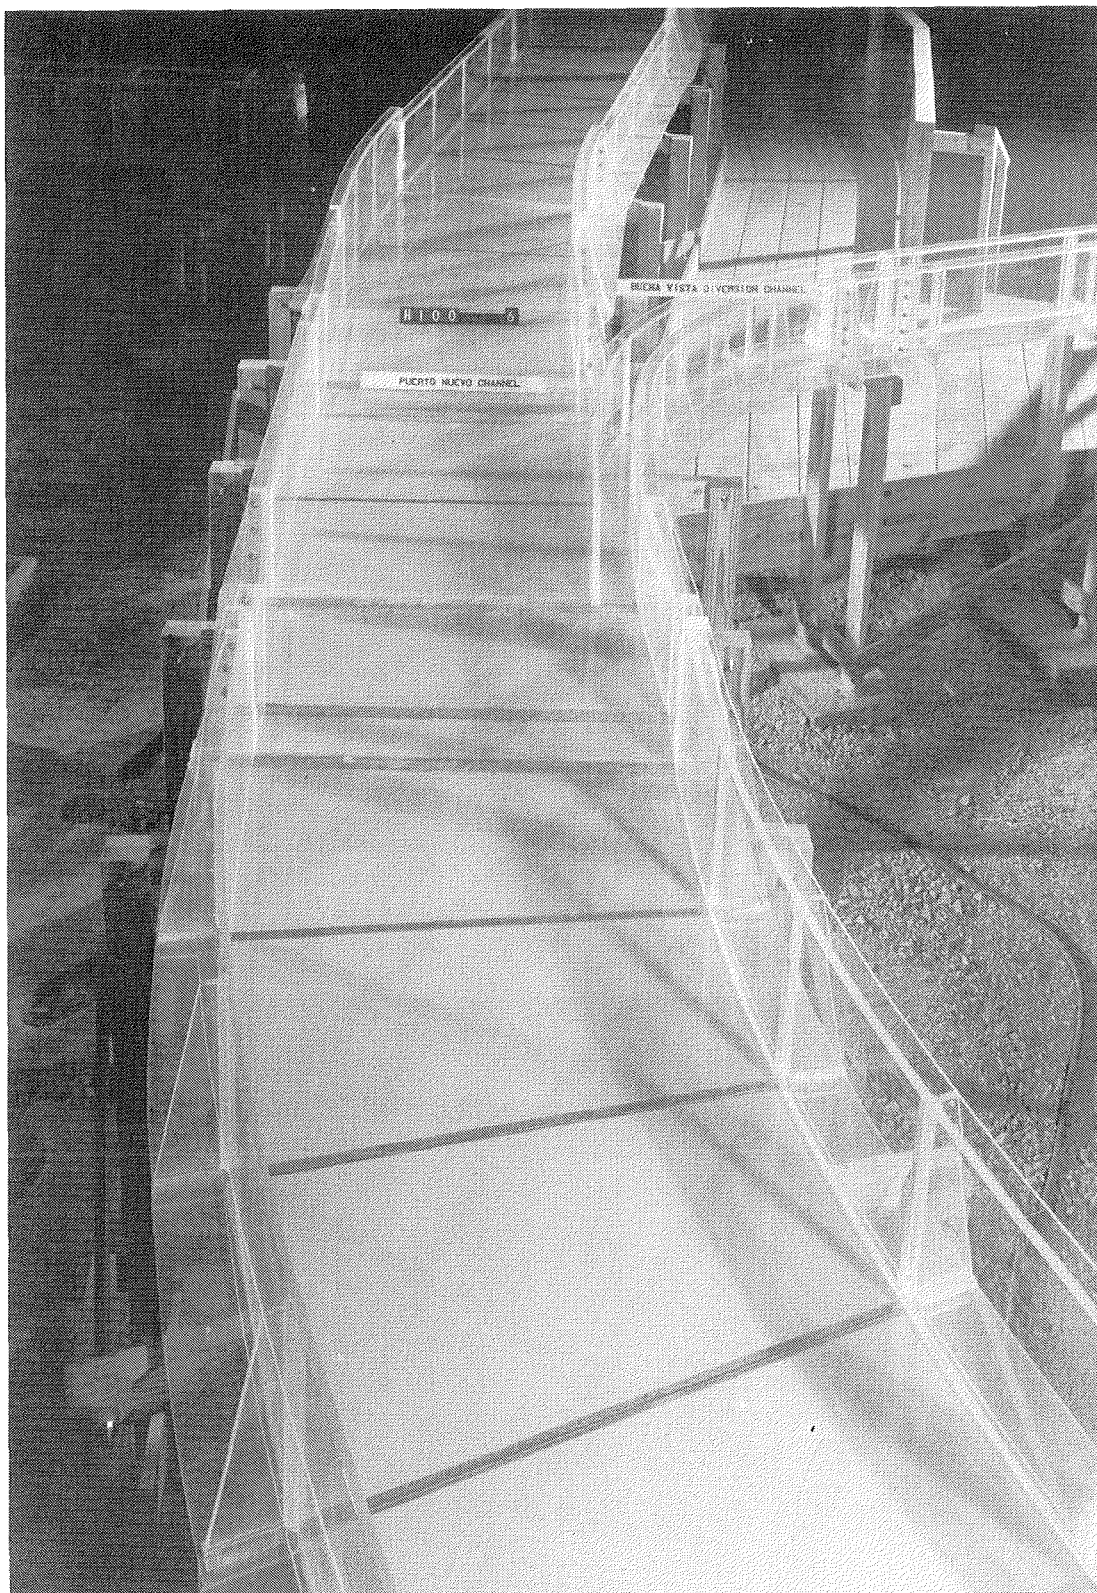
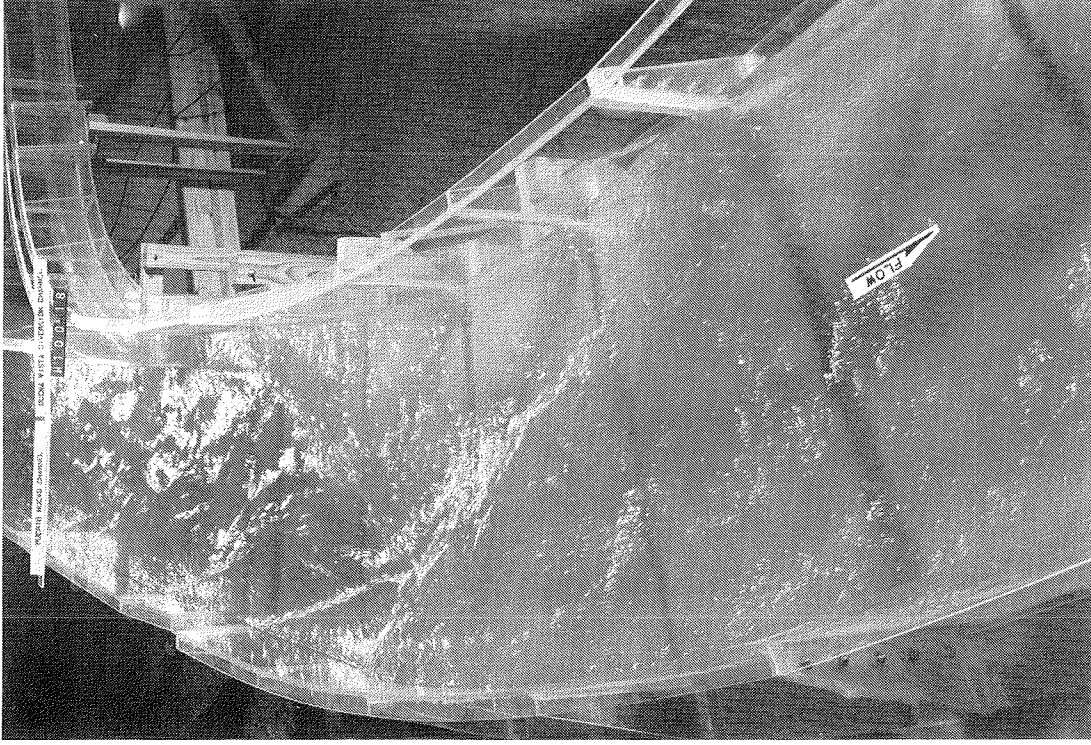
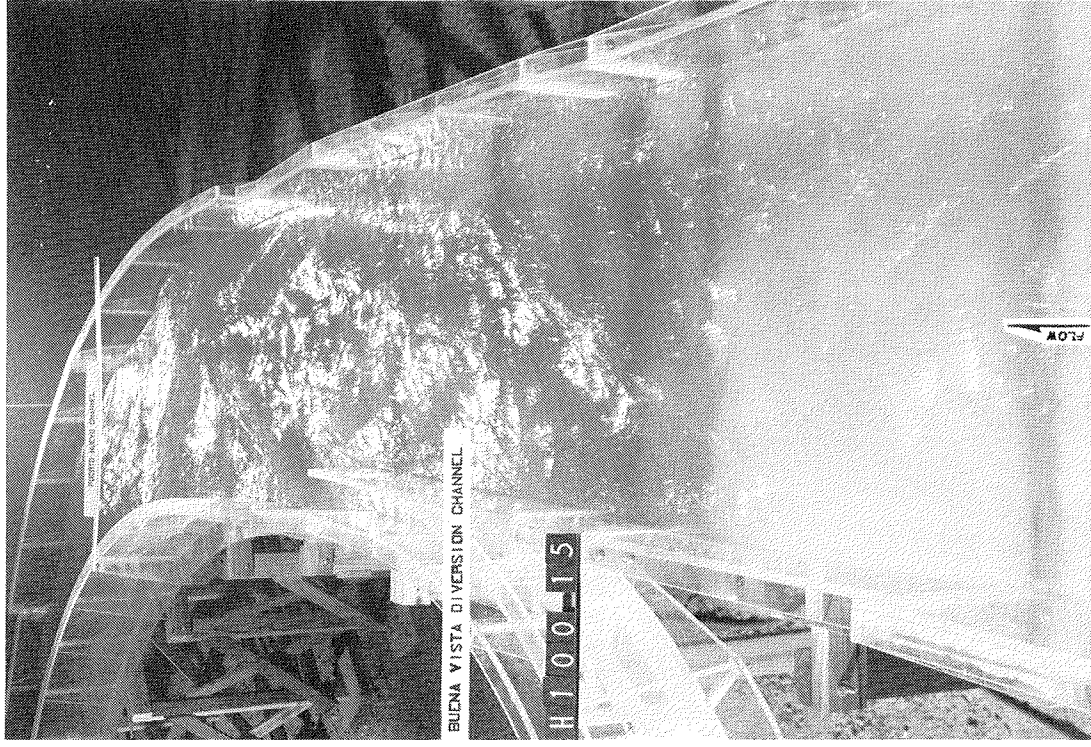
a. Dry bed (looking upstream)

Photo 2. Flow conditions, type 1 (original) design, Puerto Nuevo/Buena Vista Diversion Channel confluence, discharge 37,900 cfs in Puerto Nuevo, 4,200 cfs in Buena Vista, $n = 0.015$ (Continued)

b. Looking upstream

c. Looking downstream

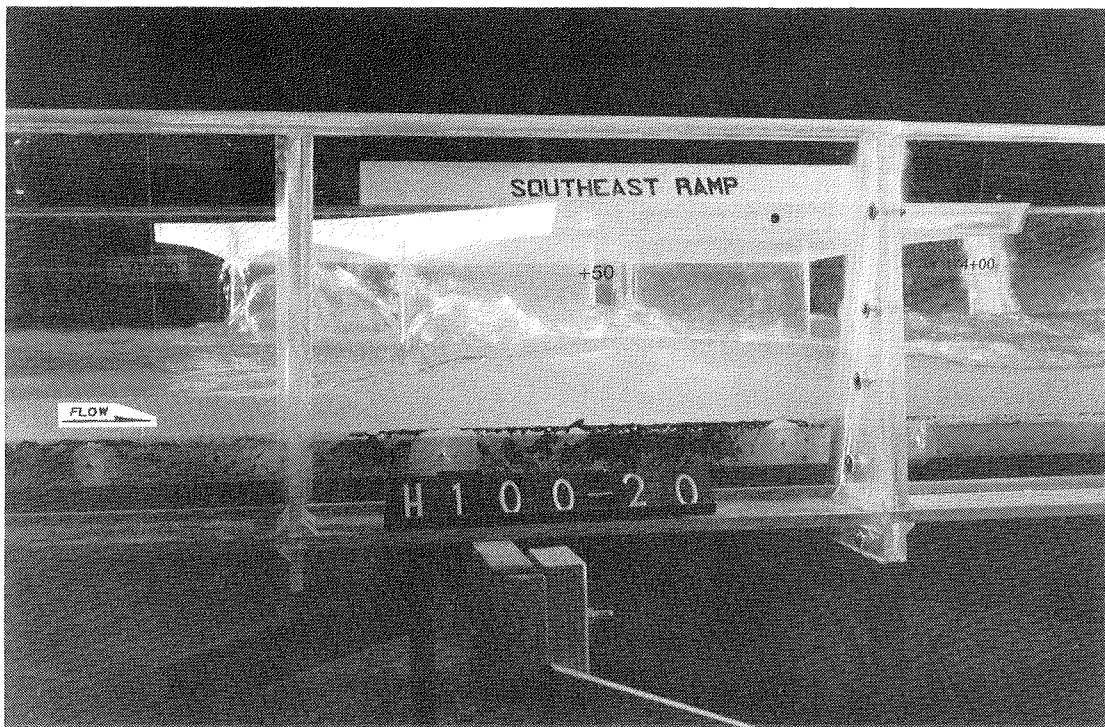
b. Elevation view

Photo 3. Flow conditions, Southeast Ramp Bridge,
discharge 44,600 cfs, $n = 0.015$

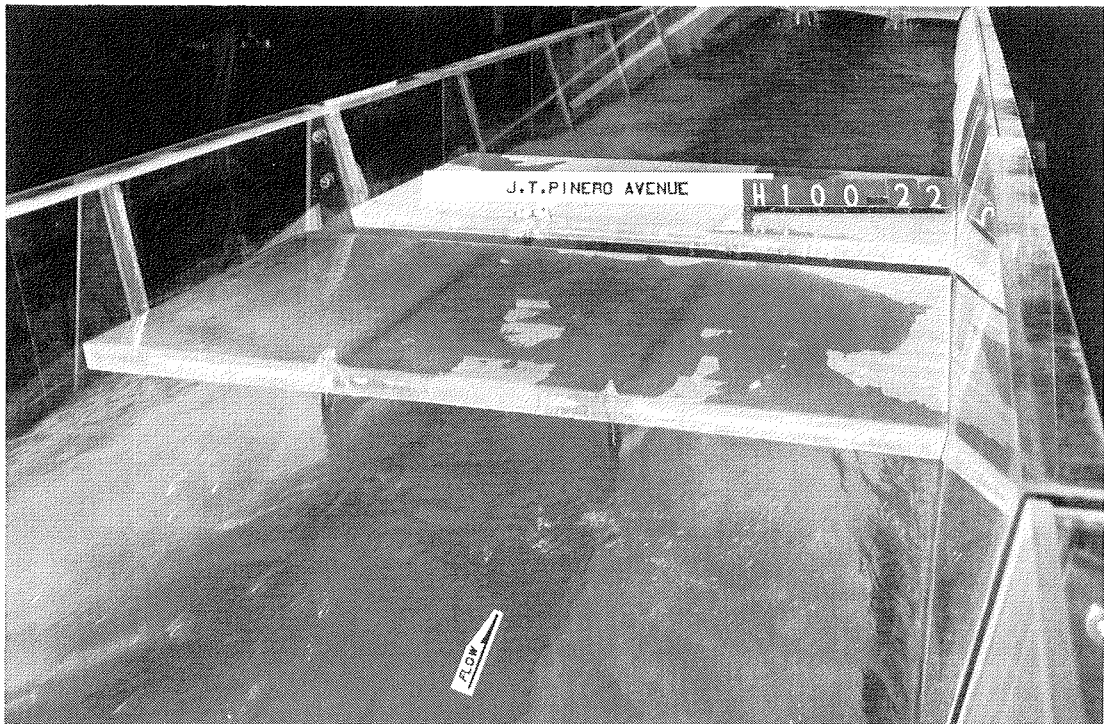
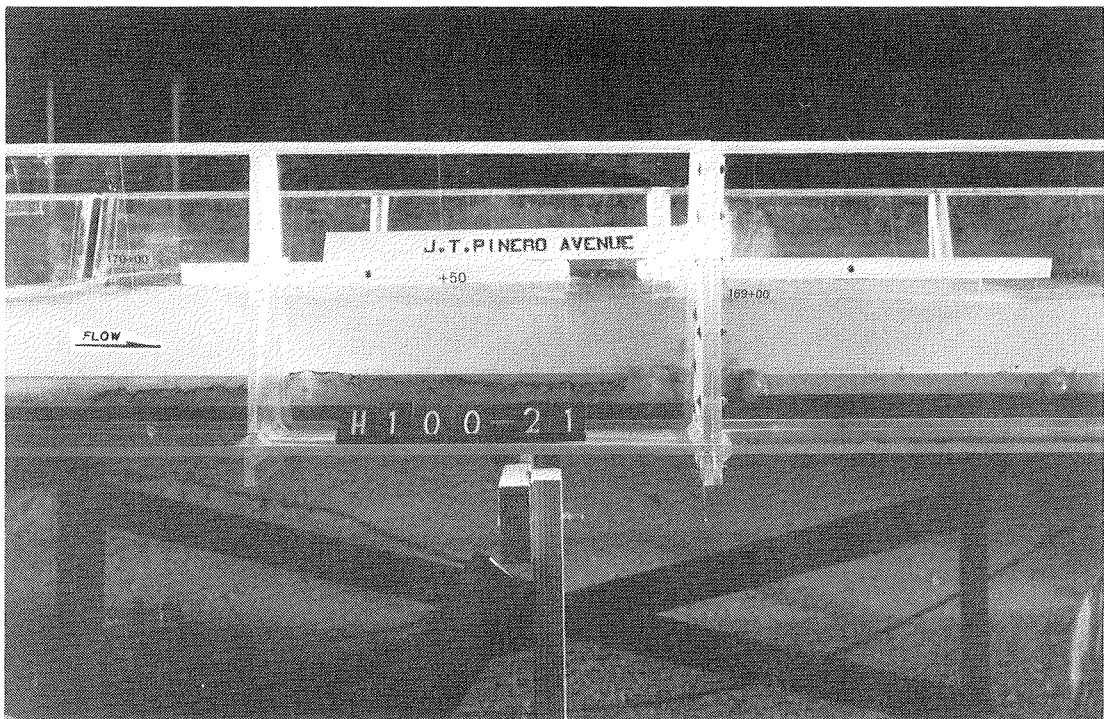
a. Looking downstream

b. Elevation view

Photo 4. Flow conditions, Pinero Avenue Bridge,
discharge 44,600 cfs, $n = 0.015$

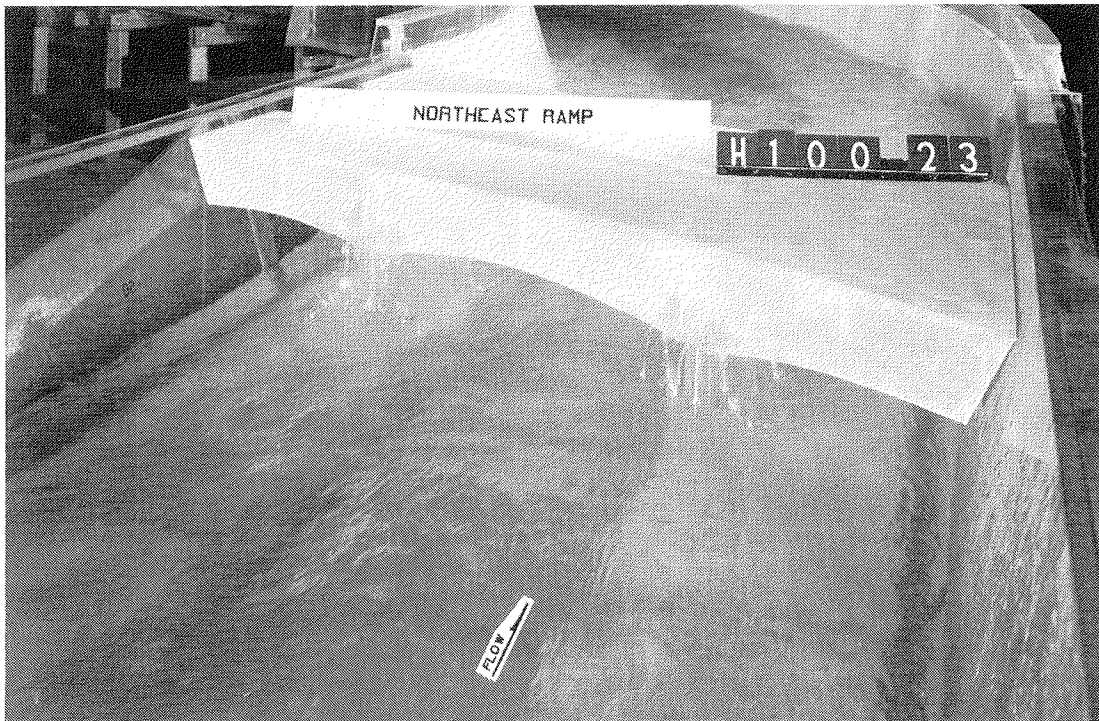
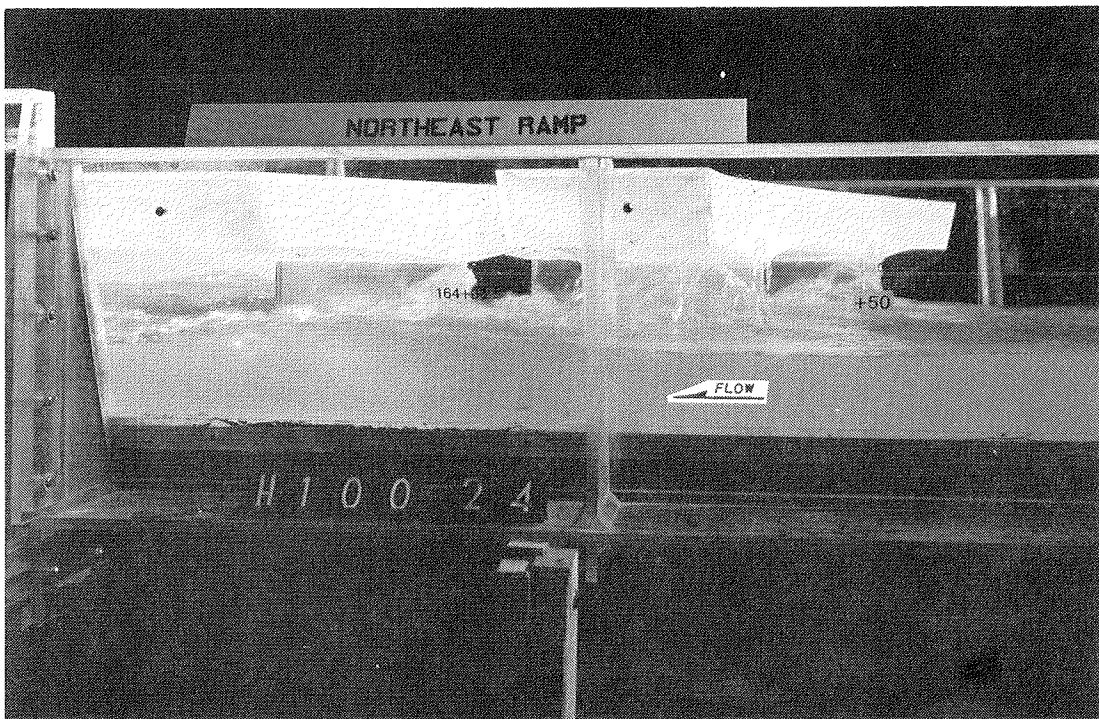
a. Looking downstream

b. Elevation view

Photo 5. Flow conditions, Northeast Ramp Bridge,
discharge 44,600 cfs, $n = 0.015$

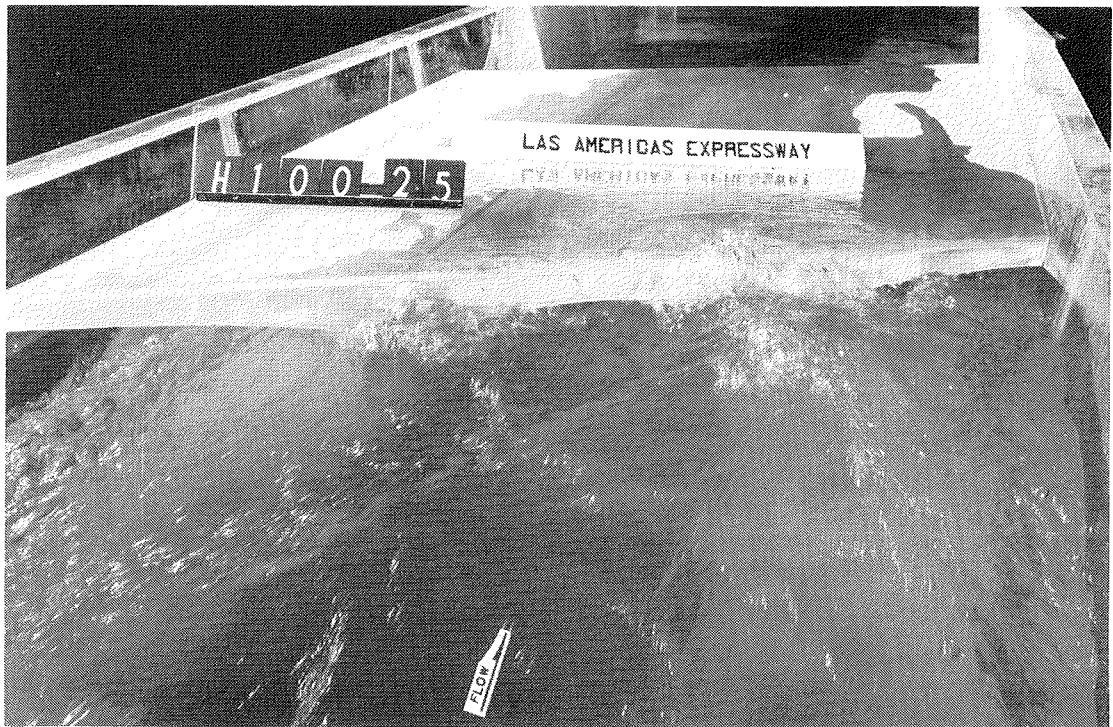
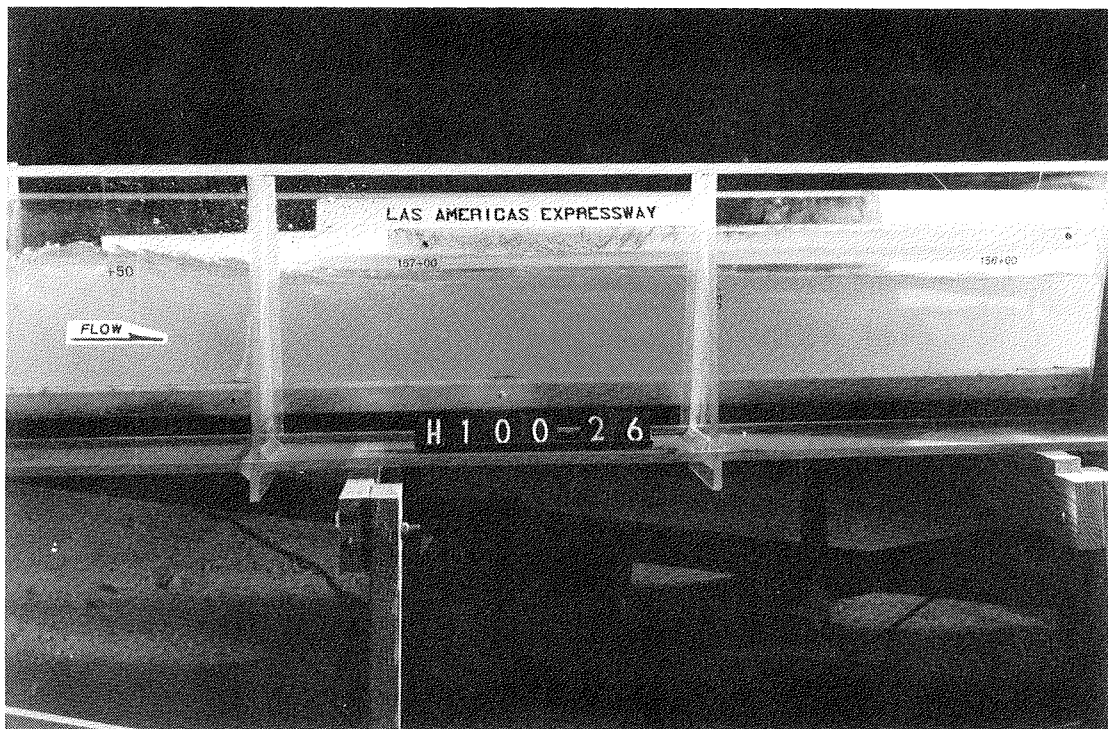
a. Looking downstream

b. Elevation view

Photo 6. Flow conditions, Las Americas Expressway Bridge,
discharge 44,600 cfs, $n = 0.015$

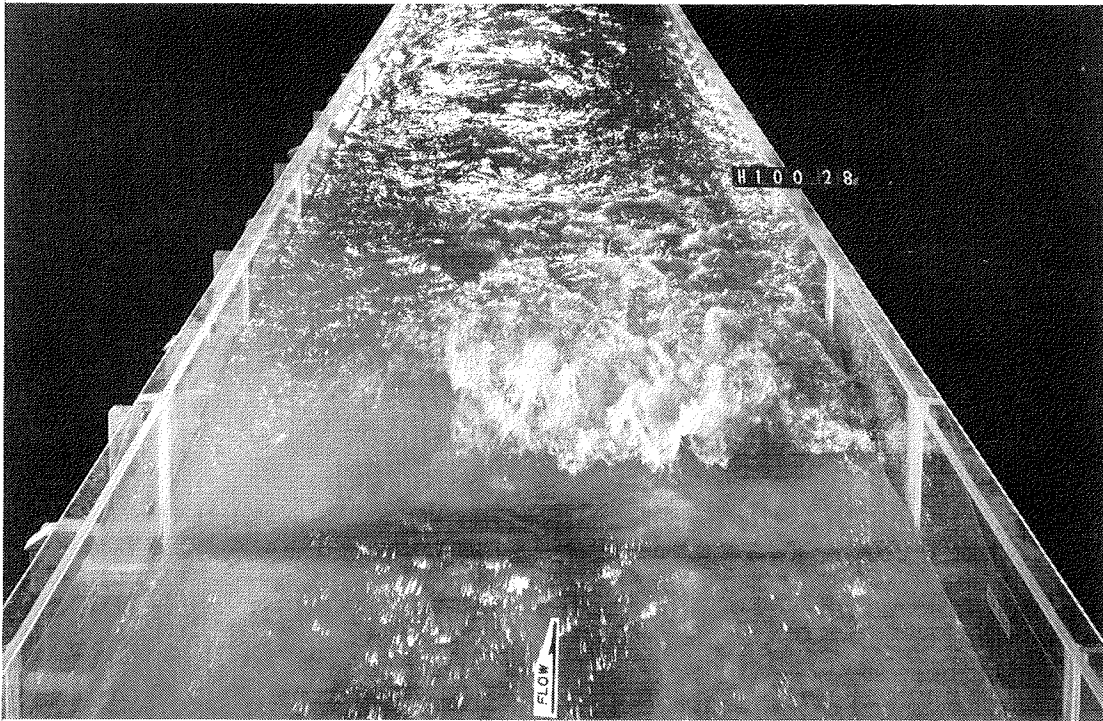
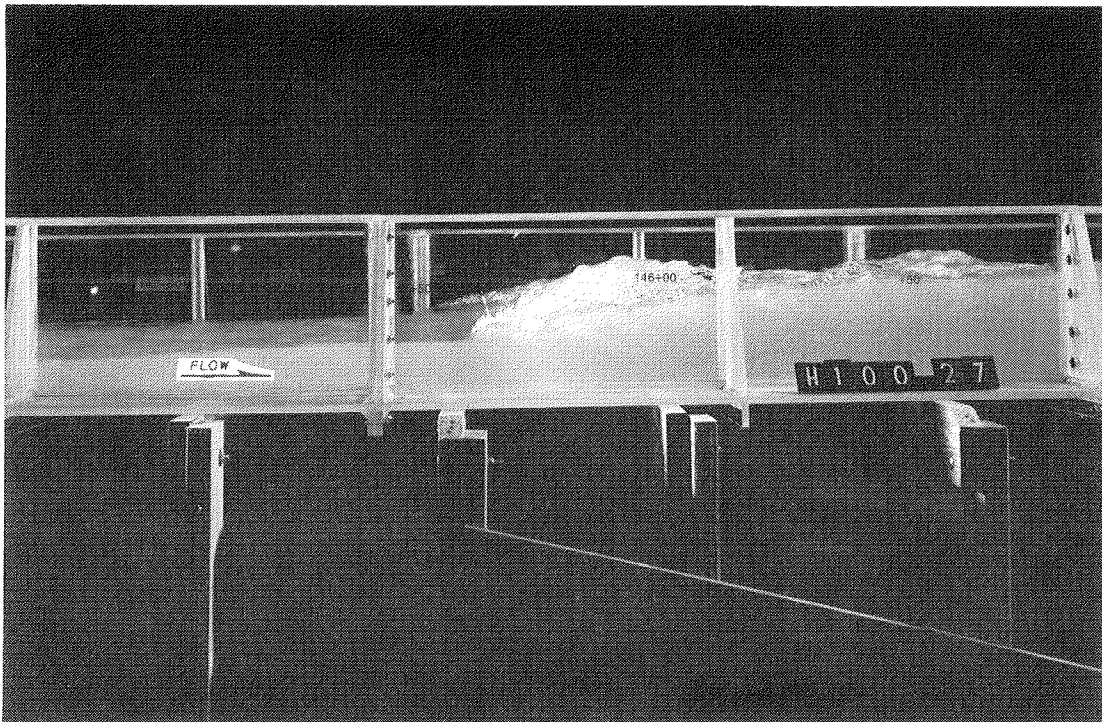
a. Looking downstream

b. Elevation view

Photo 7. Flow conditions in the vicinity of the hydraulic jump,
type 1 (original) design, discharge 44,900 cfs, $n = 0.015$
